**Flood Control Project Maintenance  
Levee Inspections**  
**LMA District Cover Sheet**  
**Spring 2017 Levee Inspection Results**

**Reclamation District No. 0999 Netherlands**

**Spring 2017 Levee Inspection Results**

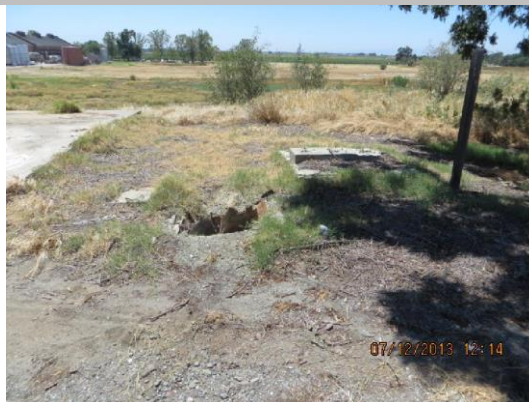
Photo 2 of 3 : UCIP\_SP\_2017\_15728\_26188.jpg

LM Start	<b>0.91</b>	Rating **	M	Issue No.	<b>59 (cont)</b>
LM End	<b>0.91</b>	Issue Type +	En	Location *	LS

Pipes visible in concrete well on LS shoulder.

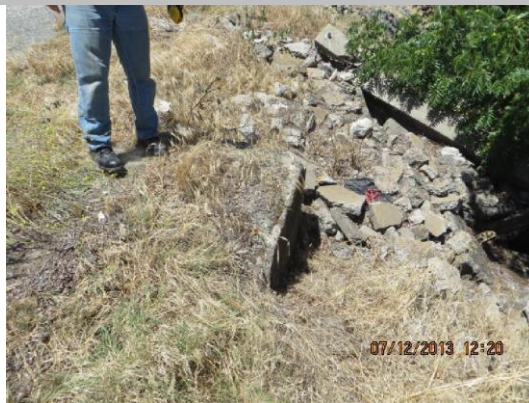
Photo 3 of 3 : UCIP\_SP\_2017\_15727\_26184.jpg

LM Start	<b>0.91</b>	Rating **	M	Issue No.	<b>60 (cont)</b>
LM End	<b>0.91</b>	Issue Type +	En	Location *	LS

Assumed pipes inside concrete well on WS shoulder at same location.

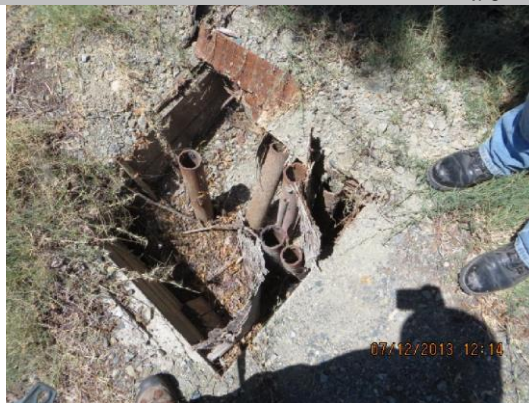
Photo 1 of 3 : UCIP\_SP\_2017\_16384\_27649.jpg

LM Start	0.91	Rating **	M	Issue No.	61
LM End	0.91	Issue Type +	En	Location *	LS
Category	Supplemental			GPS Latitude/Longitude	
				Start	End
Item	DWR UCIP Field Study			38.425514 °	38.425514 °
				-121.530970 °	-121.530970 °
DWR ID					
Comment Code					
Inspector Comment					
FS_ID:16384 DS_ID:22807 EP_NO: N/A Repair Type: Non-Urgent Crossing Status: Found UCIP Comments: Pipe abandoned and should be done so properly. FIELD_STRUCT_DESC: *ABANDONED* 3 of 6: 3.5-inch pipe through levee 2.5 feet below crown. Pipe visible in concrete well on LS and WS shoulders. FS Date: 7/12/2013

Pipe in concrete vault on WS shoulder.

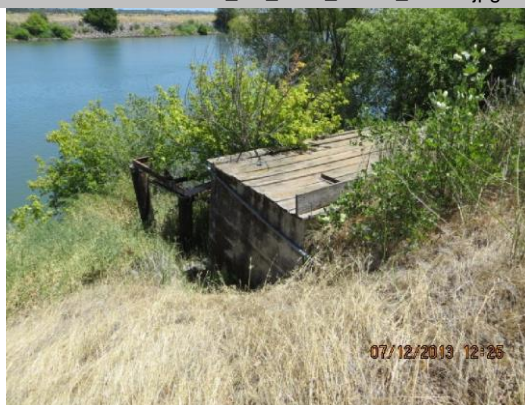
Photo 1 of 3 : UCIP\_SP\_2017\_16387\_27664.jpg

LM Start	1.00	Rating **	M	Issue No.	63
LM End	1.00	Issue Type +	En	Location *	LS
Category	Supplemental			GPS Latitude/Longitude	
				Start	End
Item	DWR UCIP Field Study			38.426709 °	38.426709 °
				-121.531725 °	-121.531725 °
DWR ID					
Comment Code					
Inspector Comment					
FS_ID:16387 DS_ID:22800 EP_NO: N/A Repair Type: Non-Urgent Crossing Status: Found UCIP Comments: Pipe appears abandoned and should be done so properly. FIELD_STRUCT_DESC: 24-inch pipe through the levee 13.0 feet below the crown. Pipe measures 16-inches in diameter on WS and 24-inches on the LS toe. Gate valve in 9'X18' concrete well on the waterward slope. Slant pump missing from waterward slope. Concrete distribution house/box at LS toe. 1.5-inch galvanized iron electrical conduit at same location. Originally included in the 1966 O&M manual. FS Date: 7/12/2013

Slide gate in 9'X18' concrete box on WS slope.

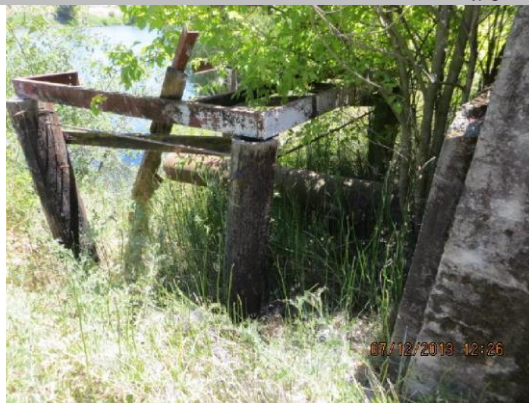
Photo 2 of 3 : UCIP\_SP\_2017\_16387\_27663.jpg

LM Start	<b>1.00</b>	Rating **	M	Issue No.	<b>63 (cont)</b>
LM End	<b>1.00</b>	Issue Type +	En	Location *	LS

Slant pump missing from pier on WS slope.

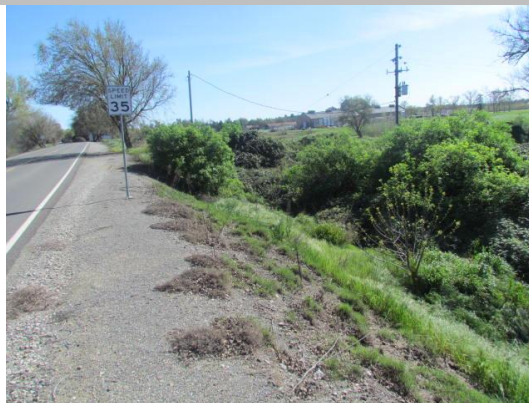
Photo 1 of 4 : SP\_2017\_RD0999\_235\_16\_20170314\_00013.jpg

LM Start	1.01	Rating **	U	Issue No.	16
LM End	1.04	Issue Type +	Ma	Location *	LS
Category	Earthen Levee			GPS Latitude/Longitude	
				Start	End
Item	Vegetation			38.426873 °	38.427295 °
				-121.531778 °	-121.532164 °
DWR ID	DWR_RD0999_04_f_2012_16				
Comment Code					
V2 : Remove the wild growth other than native grasses from the levee slopes.					
Inspector Comment					
Blackberries blocking view of landward toe.

Looking southwest at dense vegetation on landward slope and toe.  
(Spring 2016)

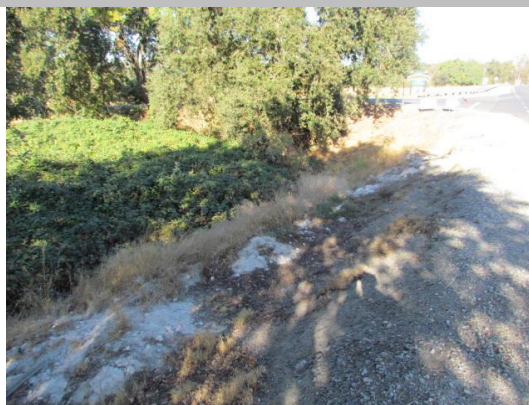
Photo 2 of 4 : SP\_2017\_RD0999\_235\_16\_20170314\_00014.jpg

Looking northwest at dense vines at landward toe. Fall 2015

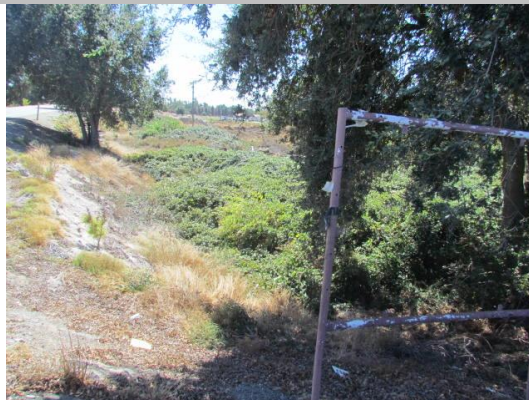
Photo 3 of 4 : SP\_2017\_RD0999\_235\_16\_20170314\_00015.jpg

Looking southwest at dense berry vines at landward toe. 2013

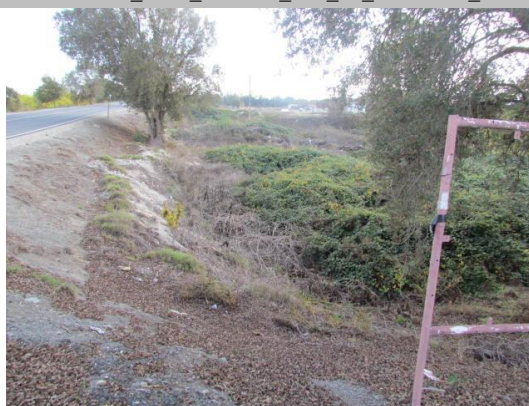
Photo 4 of 4 : SP\_2017\_RD0999\_235\_16\_20170314\_00016.jpg

LM Start	1.01	Rating **	U	Issue No.	16 (cont)	
LM End	1.04	Issue Type +	Ma	Location *	LS	
Category	Earthen Levee			GPS Latitude/Longitude		
				Start		End
Item	Vegetation			38.426873 °		38.427295 °
				-121.531778 °		-121.532164 °
DWR ID	DWR_RD0999_04_f_2012_16					
Comment Code						
V2 : Remove the wild growth other than native grasses from the levee slopes.						
Inspector Comment						
Blackberries blocking view of landward toe.

Looking south at dense berryvines on landside toe. 2012

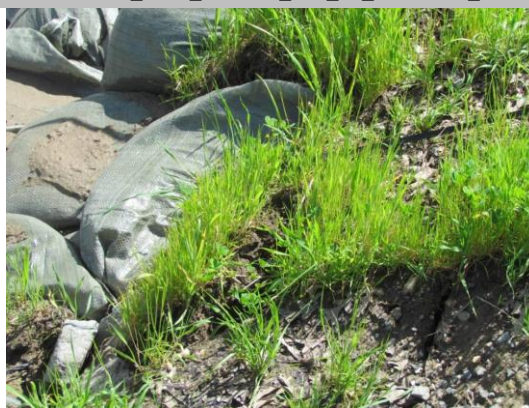
Photo 1 of 2 : SP\_2017\_RD0999\_235\_47\_20170324\_00076.jpg

LM Start	1.10	Rating **	U	Issue No.	47
LM End	1.10	Issue Type +	Ma	Location *	WS
Category	Earthen Levee			GPS Latitude/Longitude	
				Start	End
Item	Erosion / Bank Caving			38.428152 °	38.428152 °
				-121.532502 °	-121.532502 °
DWR ID	DWR_RD0999_04_s_2017_47				
Comment Code					
E1 : Note and monitor erosion site.					
Inspector Comment					
Small erosion just above rip rap on waterward toe.

Looking downstream at erosion just above rock.

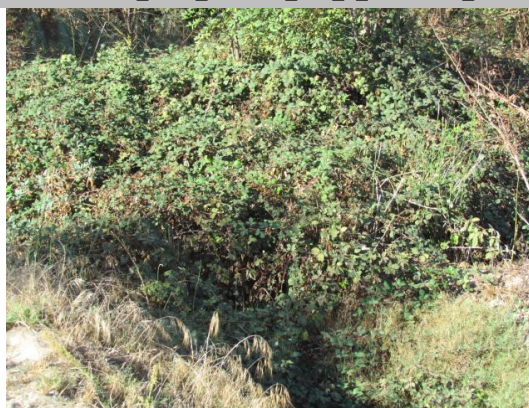
Photo 1 of 3 : SP\_2017\_RD0999\_235\_5\_20170314\_00002.jpg

LM Start	1.15	Rating **	U	Issue No.	5
LM End	1.15	Issue Type +	Ma	Location *	LS
Category	Earthen Levee			GPS Latitude/Longitude	
				Start	End
Item	Vegetation			38.428823 °	38.428823 °
				-121.532885 °	-121.532885 °
DWR ID	DWR_RD0999_04_s_2012_5				
Comment Code					
V2 : Remove the wild growth other than native grasses from the levee slopes.					
Inspector Comment					
Berry vines and wild roses on landside toe.

Looking at dense vines at landward toe. Fall 2015.

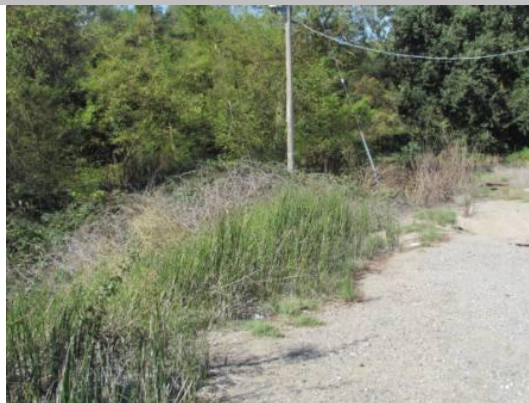
Photo 2 of 3 : SP\_2017\_RD0999\_235\_5\_20170314\_00003.jpg

Looking north at dense vegetation on landside slope near ramp.

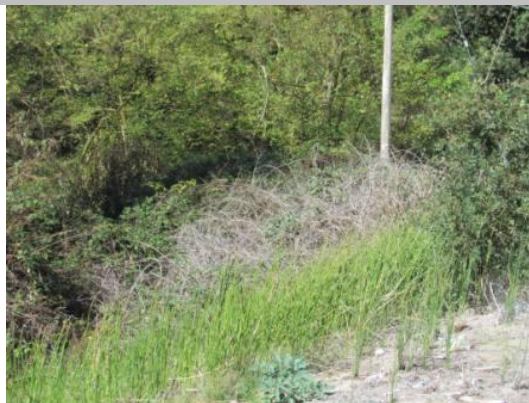
Photo 3 of 3 : SP\_2017\_RD0999\_235\_5\_20170314\_00004.jpg

LM Start	1.15	Rating **	U	Issue No.	5 (cont)	
LM End	1.15	Issue Type +	Ma	Location *	LS	
Category	Earthen Levee			GPS Latitude/Longitude		
				Start		End
Item	Vegetation			38.428823 °		38.428823 °
				-121.532885 °		-121.532885 °
DWR ID	DWR_RD0999_04_s_2012_5					
Comment Code						
V2 : Remove the wild growth other than native grasses from the levee slopes.						
Inspector Comment						
Berry vines and wild roses on landside toe.

Looking northwest at dense wild roses and berry vines on landside toe near ramp.

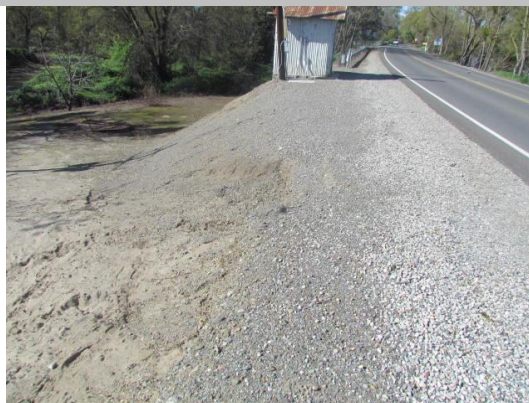
Photo 1 of 4 : SP\_2017\_RD0999\_235\_40\_20170314\_00027.jpg

LM Start	1.16	Rating **	U	Issue No.	40
LM End	1.16	Issue Type +	Ma	Location *	LS
Category	Earthen Levee			GPS Latitude/Longitude	
				Start	End
Item	Erosion / Bank Caving			38.428877 °	38.428877 °
				-121.532922 °	-121.532922 °
DWR ID	DWR_RD0999_04_f_2015_40				
Comment Code					
E2 : Schedule repair of erosion site prior to the next inspection.					
Inspector Comment					
Large hole and erosion on landward shoulder, slope and toe.

Looking east at erosion on landward shoulder and slope. (Spring 2016)

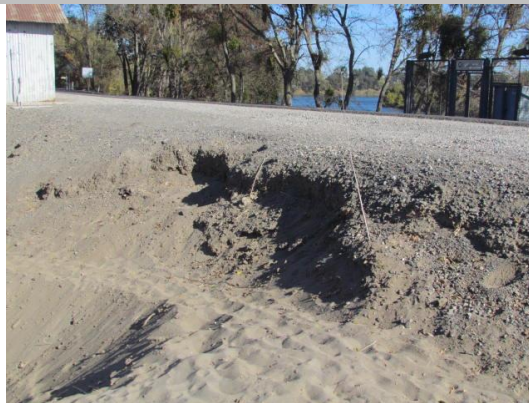
Photo 2 of 4 : SP\_2017\_RD0999\_235\_40\_20170314\_00028.jpg

Looking east at erosion on landward shoulder.

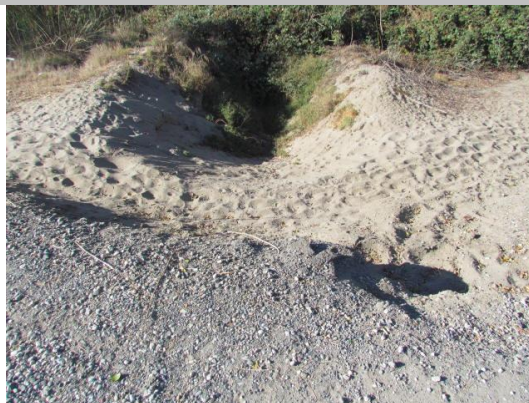
Photo 3 of 4 : SP\_2017\_RD0999\_235\_40\_20170314\_00029.jpg

LM Start	1.16	Rating **	U	Issue No.	40 (cont)	
LM End	1.16	Issue Type +	Ma	Location *	LS	
Category	Earthen Levee			GPS Latitude/Longitude		
				Start		End
Item	Erosion / Bank Caving			38.428877 °		38.428877 °
				-121.532922 °		-121.532922 °
DWR ID	DWR_RD0999_04_f_2015_40					
Comment Code						
E2 : Schedule repair of erosion site prior to the next inspection.						
Inspector Comment						
Large hole and erosion on landward shoulder, slope and toe.

Looking west at caving at landward slope and toe.

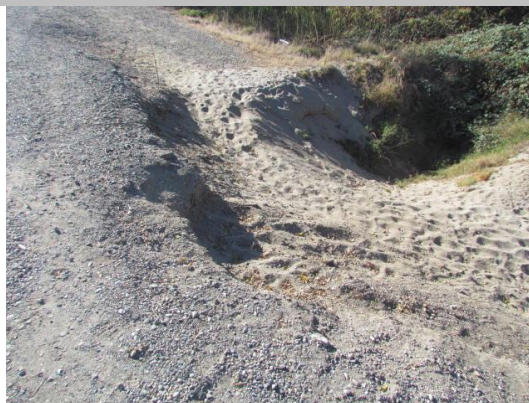
Photo 4 of 4 : SP\_2017\_RD0999\_235\_40\_20170314\_00030.jpg

Looking southwest at shoulder erosion and caving at landward slope and toe.

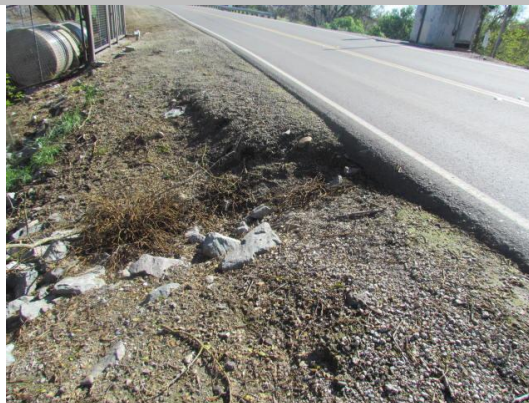
Photo 2 of 2 : SP\_2017\_RD0999\_235\_46\_20170314\_00032.jpg

LM Start	1.18	Rating **	U	Issue No.	46 (cont)	
LM End	1.18	Issue Type +	Ma	Location *	WS	
Category	Earthen Levee			GPS Latitude/Longitude		
				Start	End	
Item	Erosion / Bank Caving			38.429201 °	38.429201 °	
				-121.533012 °	-121.533012 °	
DWR ID	DWR_RD0999_04_s_2016_46					
Comment Code						
E2 : Schedule repair of erosion site prior to the next inspection.						
Inspector Comment						
Erosion located just below asphalt on waterward shoulder.

Looking south at foot erosion on waterward shoulder and slope.

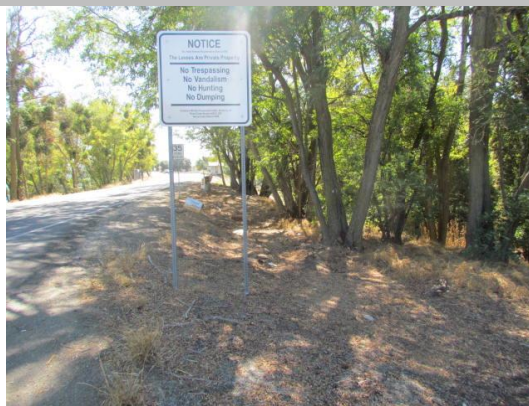
Photo 1 of 1 : SP\_2017\_RD0999\_235\_22\_20170314\_00020.jpg

LM Start	1.20	Rating **	M	Issue No.	22
LM End	1.22	Issue Type +	Ma	Location *	LS
Category	Earthen Levee			GPS Latitude/Longitude	
				Start	End
Item	Trim / Thin Trees			38.429467 °	38.429750 °
				-121.533110 °	-121.533188 °
DWR ID	DWR_RD0999_04_f_2013_22				
Comment Code					
T3 : Trim and thin trees to allow visibility of the ground and room to flood fight.					
Inspector Comment

Looking south at dense trees on landward slope.

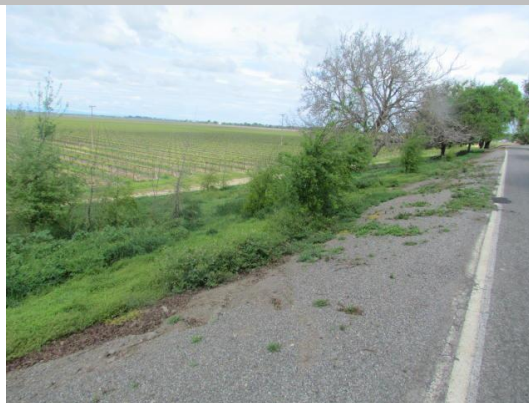
Photo 1 of 1 : SP\_2017\_RD0999\_236\_178\_20170314\_00123.jpg

LM Start	0.02	Rating **	M	Issue No.	178
LM End	0.05	Issue Type +	Ma	Location *	LS
Category	Earthen Levee			GPS Latitude/Longitude	
				Start	End
Item	Trim / Thin Trees			38.332946 °	38.333308 °
				-121.584502 °	-121.584494 °
DWR ID	DWR_RD0999_05_s_2015_178				
Comment Code					
T3 : Trim and thin trees to allow visibility of the ground and room to flood fight.					
Inspector Comment					
Remove trees under an inch in diameter on landward slope. Don't allow young trees to get established.

Looking at typical view of young oak trees on landward slope. (Spring 2015)

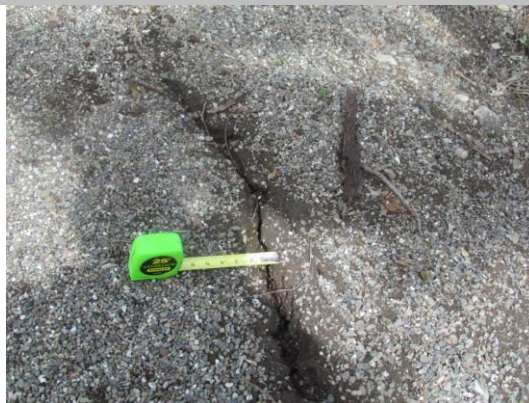
Photo 1 of 3 : SP\_2017\_RD0999\_236\_165\_20170324\_00232.jpg

LM Start	0.11	Rating **	U	Issue No.	165
LM End	0.12	Issue Type +	Ma	Location *	WS
Category	Earthen Levee			GPS Latitude/Longitude	
				Start	End
Item	Slope Stability			38.334198 °	38.334327 °
				-121.584308 °	-121.584275 °
DWR ID	DWR_RD0999_05_s_2017_165				
Comment Code					
S1 : Repair slope instability.					
Inspector Comment					
Crack greater than two inches along top of half of waterward slope. Three dead trees along slope damage section. Trees should be removed.

Looking at two inch plus crack on waterward shoulder.

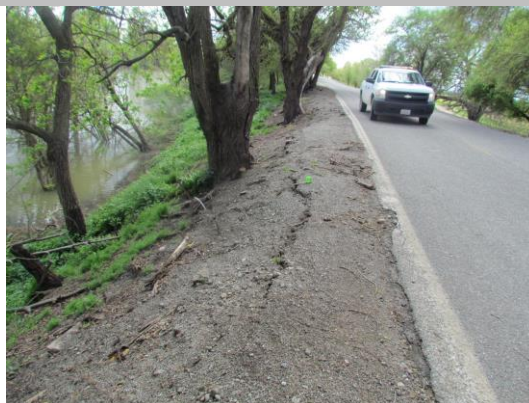
Photo 3 of 3 : SP\_2017\_RD0999\_236\_165\_20170324\_00234.jpg

Looking downstream at crack along waterward shoulder.

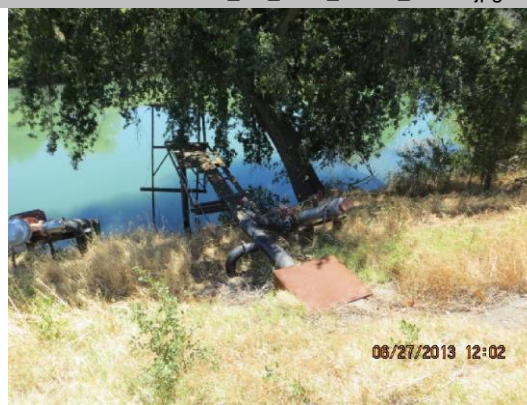
Photo 1 of 3 : UCIP\_SP\_2017\_15411\_25295.jpg

Comment Code					
Inspector Comment					
FS_ID:15411					
DS_ID:22839					
EP_NO: N/A					
Repair Type: Non-Urgent					
Crossing Status: Found					
UCIP Comments: Walkway to pump on pier is falling appart and should be removed.					
FIELD_STRUCT_DESC: 12-inch pipe through levee 11.0 feet below crown. 10-inch pipe visible on slopes and at Slant pump on waterward slope (Pump on structure removed). Additional slant pump on WS slope ties into pipe at WS. 30-inch steel standpipe on LS toe. Butterfly valves located on both sides of levee. 3'X3' steel junction box on WS shoulder and a 31"X60" steel junction box on LS shoulder. Service pole on both slopes. Originally included in the 1966 O&M manual.					
FS Date: 6/27/2013

Pump and steel junction box visible on WS slope.

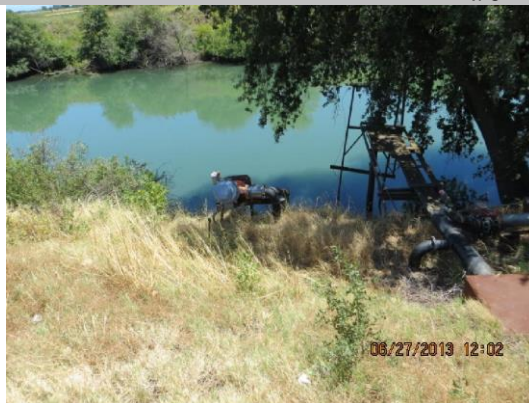
Photo 2 of 3 : UCIP\_SP\_2017\_15411\_25294.jpg

2nd Pump visible on WS slope.

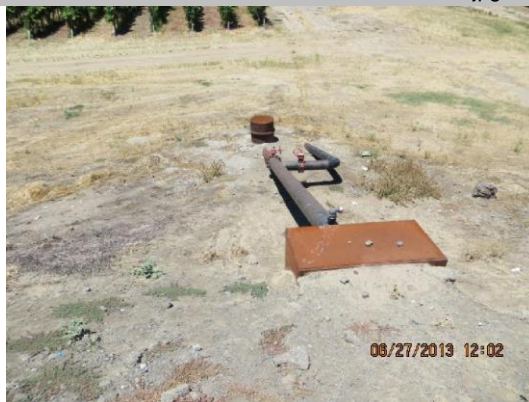
Photo 3 of 3 : UCIP\_SP\_2017\_15411\_25293.jpg

Steel junction box, vent, butterfly valve, and standpipe visible on LS slope.

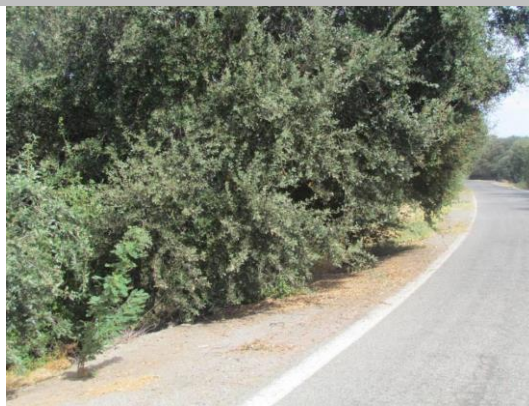
Photo 1 of 2 : SP\_2017\_RD0999\_236\_8\_20170314\_00005.jpg

LM Start	0.37	Rating **	U	Issue No.	8
LM End	0.45	Issue Type +	En	Location *	LS
Category	Earthen Levee			GPS Latitude/Longitude	
				Start	End
Item	Trim / Thin Trees			38.337654 °	38.338790 °
				-121.582427 °	-121.582184 °
DWR ID	DWR_RD0999_05_s_2012_8				
Comment Code					
T3 : Trim and thin trees to allow visibility of the ground and room to flood fight.					
Inspector Comment

Looking northwest at dense vegetation on landward slope. (Fall 2016)

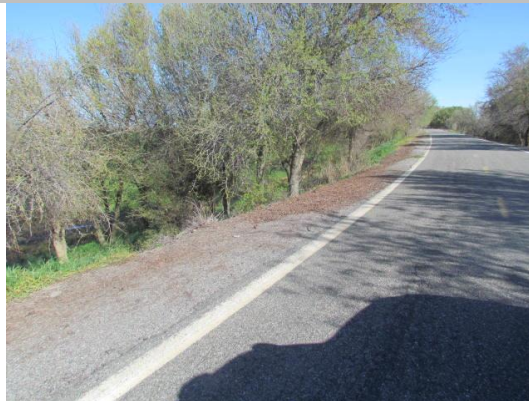
Photo 2 of 2 : SP\_2017\_RD0999\_236\_8\_20170314\_00006.jpg

Looking northwest at dense vegetation on landward slope. (Spring 2016)

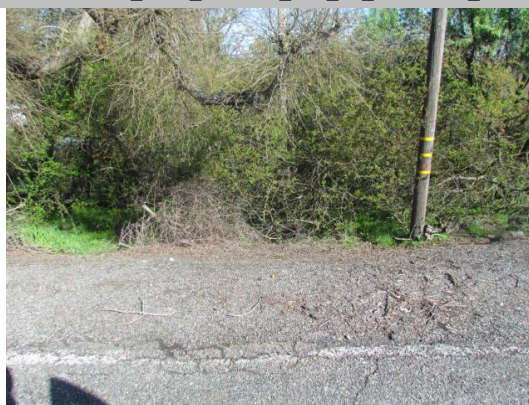
Photo 1 of 1 : SP\_2017\_RD0999\_236\_53\_20170314\_00047.jpg

LM Start	0.37	Rating **	U	Issue No.	53
LM End	0.37	Issue Type +	Ma	Location *	LS
Category	Earthen Levee			GPS Latitude/Longitude	
				Start	End
Item	Vegetation			38.337753 °	38.337753 °
				-121.582445 °	-121.582445 °
DWR ID	DWR_RD0999_05_s_2012_53				
Comment Code					
V2 : Remove the wild growth other than native grasses from the levee slopes.					
Inspector Comment

Looking west at dense vegetation on landward slope.

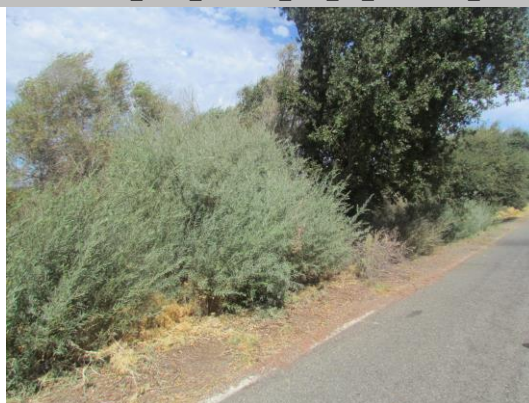
Photo 1 of 1 : SP\_2017\_RD0999\_236\_25\_20170314\_00024.jpg

LM Start	0.40	Rating **	U	Issue No.	25
LM End	0.44	Issue Type +	Ma	Location *	LS
Category	Earthen Levee			GPS Latitude/Longitude	
				Start	End
Item	Vegetation			38.338075 °	38.338688 °
				-121.582322 °	-121.582193 °
DWR ID	DWR_RD0999_05_s_2012_25				
Comment Code					
V2 : Remove the wild growth other than native grasses from the levee slopes.					
Inspector Comment					
Willows within vegetation area.

Looking southwest at dense vegetation (willows) on landward slope.

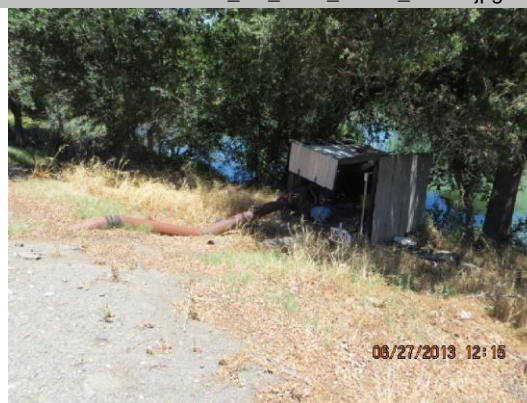
Photo 1 of 3 : UCIP\_SP\_2017\_15413\_25304.jpg

LM Start	0.50	Rating **	M	Issue No.	230
LM End	0.50	Issue Type +	En	Location *	LS
Category	Supplemental			GPS Latitude/Longitude	
				Start	End
Item	DWR UCIP Field Study			38.339607 °	38.339607 °
				-121.582091 °	-121.582091 °
DWR ID					
Comment Code					
Inspector Comment					
FS_ID:15413 DS_ID:22840 EP_NO: 6081 Repair Type: Non-Urgent Crossing Status: Found UCIP Comments: Some settlement along LS and WS slopes. Good candidate for video inspection. FIELD_STRUCT_DESC: 10-inch steel pipe through levee 3.3 feet below crown. Pump and butterfly valve in pump house on waterward slope. Vent in 10-inch steel standpipe on LS slope (Permit No. 6081,1968). Replaces an existing 10-inch pipe. FS Date: 6/27/2013

Pump in pumphouse on WSs slope.

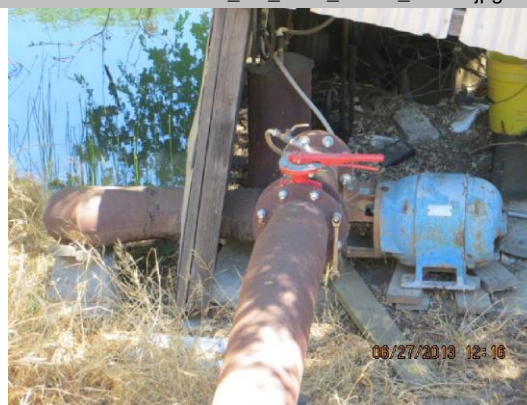
Photo 2 of 3 : UCIP\_SP\_2017\_15413\_25303.jpg

Butterfly valve at pumphouse on WS slope.

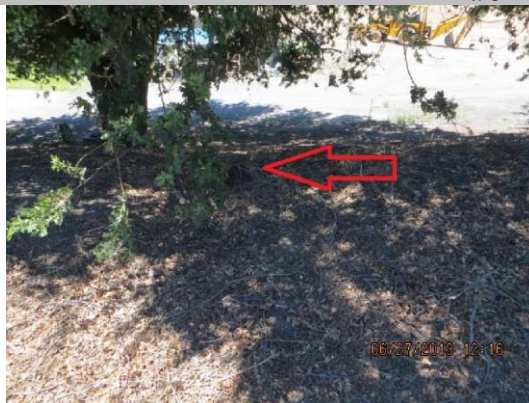
Photo 3 of 3 : UCIP\_SP\_2017\_15413\_25302.jpg

Vent in 10-inch riser on LS slope.

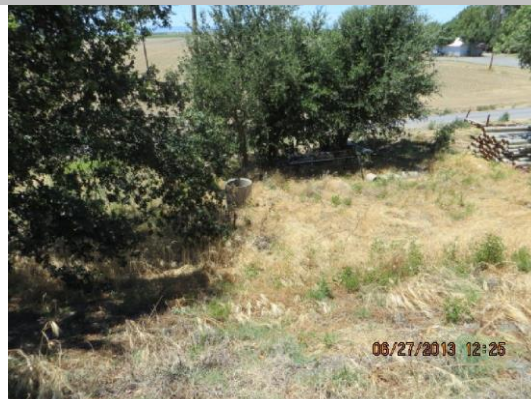
Photo 3 of 3 : UCIP\_SP\_2017\_15414\_25306.jpg

Pipe may be aligned with concrete standpipe at LS toe, but no pipe is visible on LS.

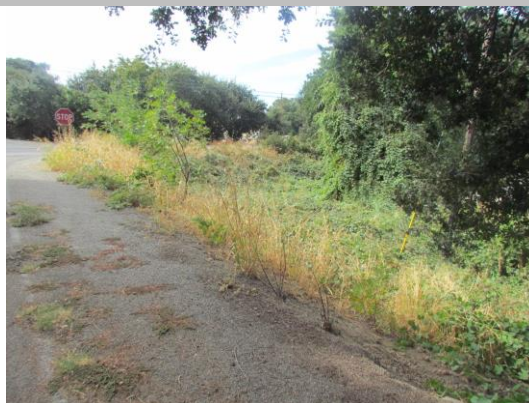
Photo 1 of 2 : SP\_2017\_RD0999\_236\_189\_20170314\_00129.jpg

LM Start	0.68	Rating **	U	Issue No.	189
LM End	0.68	Issue Type +	Ma	Location *	LS
Category	Earthen Levee			GPS Latitude/Longitude	
				Start	End
Item	Vegetation			38.342032 °	38.342032 °
				-121.581372 °	-121.581372 °
DWR ID	DWR_RD0999_05_f_2014_189				
Comment Code					
V2 : Remove the wild growth other than native grasses from the levee slopes.					
Inspector Comment					
Dense wild grapevines on landward slope.

Looking southwest at dense vegetation on landward slope and toe. (Fall 2016)

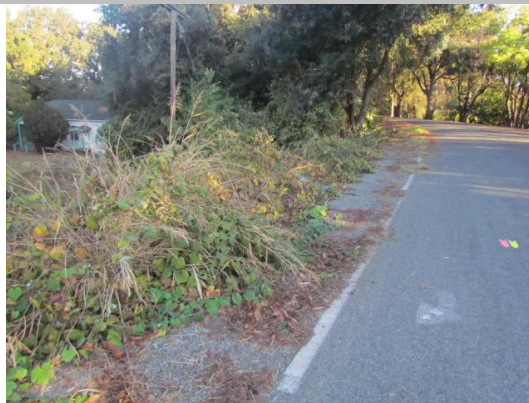
Photo 2 of 2 : SP\_2017\_RD0999\_236\_189\_20170314\_00130.jpg

Looking northwest at dense vegetation on landward slope. (Spring 2016)

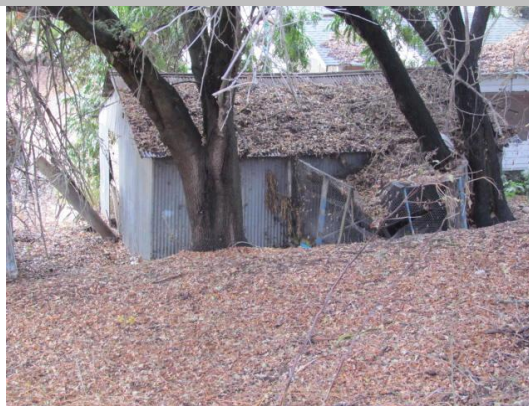
Photo 1 of 1 : SP\_2017\_RD0999\_236\_170\_20170314\_00111.jpg

LM Start	0.70	Rating **	U	Issue No.	170
LM End	0.70	Issue Type +	En	Location *	LS
Category	Earthen Levee			GPS Latitude/Longitude	
				Start	End
Item	Encroachments			38.342288 °	38.342288 °
				-121.581278 °	-121.581278 °
DWR ID	DWR_RD0999_05_f_2015_170				
Comment Code					
BU : Building					
Inspector Comment					
Toolshed at landward toe.

Looking at the toolshed at the landward toe.

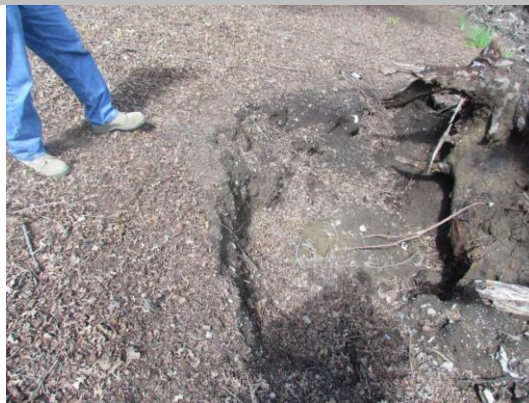
Photo 1 of 3 : SP\_2017\_RD0999\_236\_166\_20170324\_00236.jpg

LM Start	0.71	Rating **	U	Issue No.	166
LM End	0.71	Issue Type +	Ma	Location *	WS
Category	Earthen Levee			GPS Latitude/Longitude	
				Start	End
Item	Encroachments			38.342483 °	38.342483 °
				-121.581235 °	-121.581235 °
DWR ID	DWR_RD0999_05_s_2017_166				
Comment Code					
TR : Tree or limb					
Inspector Comment					
Dead tree fallen on waterward slope. Left hole on waterward slope 10 to 12 inches.

Looking at hole left by fallen tree on waterward slope.

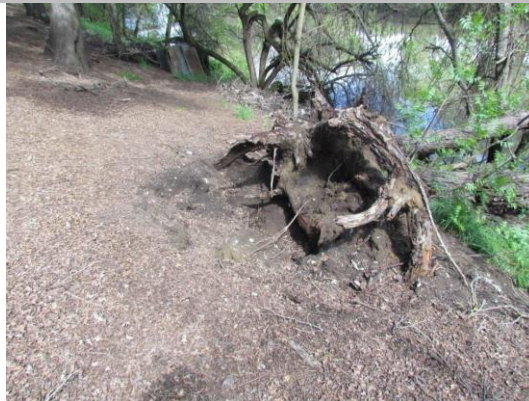
Photo 2 of 3 : SP\_2017\_RD0999\_236\_166\_20170324\_00235.jpg

Looking east at fallen tree on waterward slope.

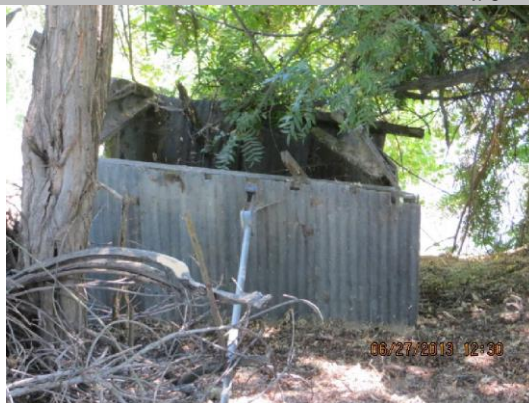
Photo 1 of 2 : UCIP\_SP\_2017\_15450\_25386.jpg

LM Start	0.72	Rating **	M	Issue No.	232
LM End	0.72	Issue Type +	En	Location *	WS
Category	Supplemental			GPS Latitude/Longitude	
				Start	End
Item	DWR UCIP Field Study			38.342653 °	38.342653 °
				-121.581236 °	-121.581236 °
DWR ID					
Comment Code					
Inspector Comment					
FS_ID:15450 DS_ID:22842 EP_NO: N/A Repair Type: Non-Urgent Crossing Status: Found UCIP Comments: Pipe abandoned and should be done so properly. FIELD_STRUCT_DESC: *Abandoned* 6-inch pipe through levee 11.5 feet below crown. Pump and gate valve in pump house on the waterward slope. 1.5-inch galvanized iron electrical conduit at same location. Originally included in the 1966 O&M manual. FS Date: 6/27/2013

Pumphouse on WS slope with electrical conduit shown.

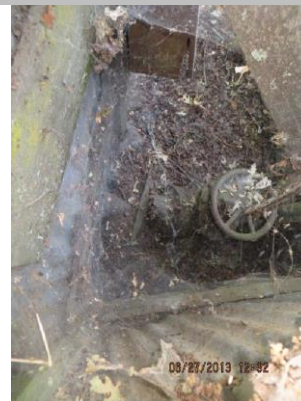
Photo 2 of 2 : UCIP\_SP\_2017\_15450\_25385.jpg

Pipe rusted through at gatevalve inside pumphouse.

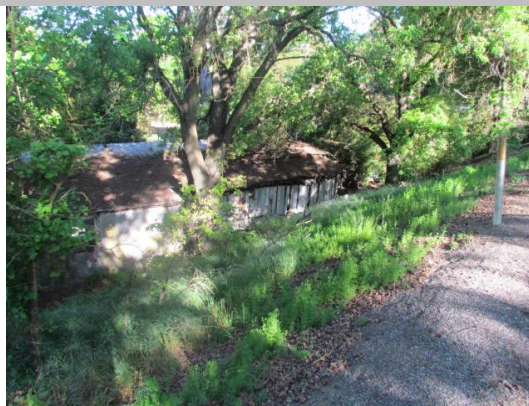
Photo 1 of 2 : SP\_2017\_RD0999\_236\_23\_20170314\_00021.jpg

LM Start	0.77	Rating **	U	Issue No.	23
LM End	0.77	Issue Type +	En	Location *	LS
Category	Earthen Levee			GPS Latitude/Longitude	
				Start	End
Item	Encroachments			38.343358 °	38.343358 °
				-121.581295 °	-121.581295 °
DWR ID	DWR_RD0999_05_f_2012_23				
Comment Code					
BU : Building					
Inspector Comment					
Storage shed at landside toe and within the 10' easement.

Looking northwest at abandoned storage shed at landward toe. (Spring 2015)

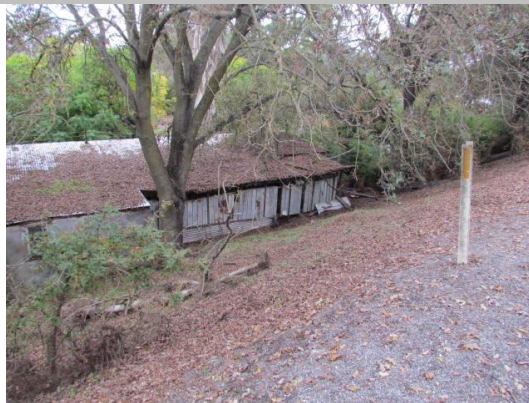
Photo 2 of 2 : SP\_2017\_RD0999\_236\_23\_20170314\_00022.jpg

Looking northwest at storage shed at landside toe and within the 10' easement.

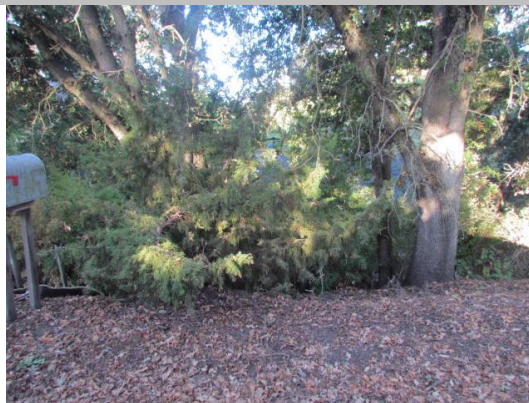
Photo 1 of 1 : SP\_2017\_RD0999\_236\_190\_20170314\_00131.jpg

LM Start	0.79	Rating **	U	Issue No.	190
LM End	0.79	Issue Type +	En	Location *	LS
Category	Earthen Levee			GPS Latitude/Longitude	
				Start	End
Item	Vegetation			38.343606 °	38.343606 °
				-121.581279 °	-121.581279 °
DWR ID	DWR_RD0999_05_f_2014_190				
Comment Code					
V6 : Landscaping					
Inspector Comment

Looking west at dense vegetation on landward slope and toe.

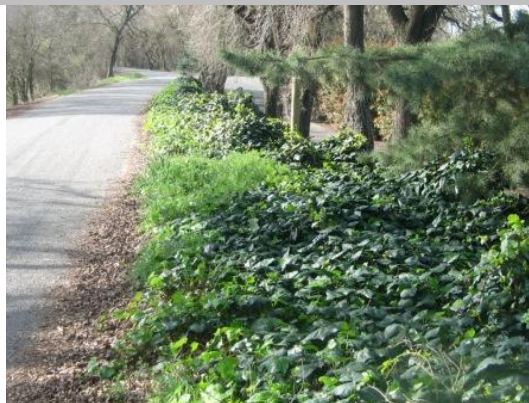
Photo 1 of 2 : SP\_2017\_RD0999\_236\_11\_20170314\_00013.jpg

LM Start	0.80	Rating **	U	Issue No.	11
LM End	0.90	Issue Type +	En	Location *	LS
Category	Earthen Levee			GPS Latitude/Longitude	
				Start	End
Item	Vegetation			38.343825 °	38.345215 °
				-121.581133 °	-121.580728 °
DWR ID	DWR_RD0999_05_s_2012_11				
Comment Code					
V6 : Landscaping					
Inspector Comment

View of landscaping (Ivy) looking upstream.

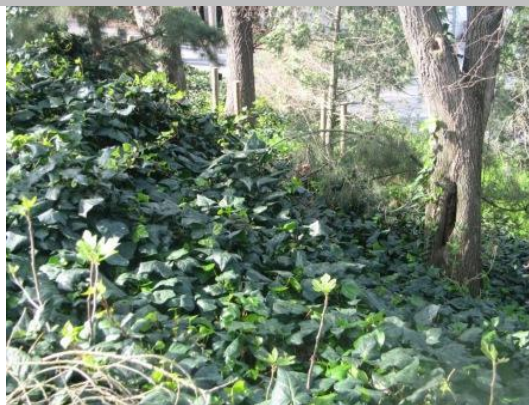
Photo 2 of 2 : SP\_2017\_RD0999\_236\_11\_20170314\_00014.jpg

View of landscaping (Ivy) blocking view of landside slope from.

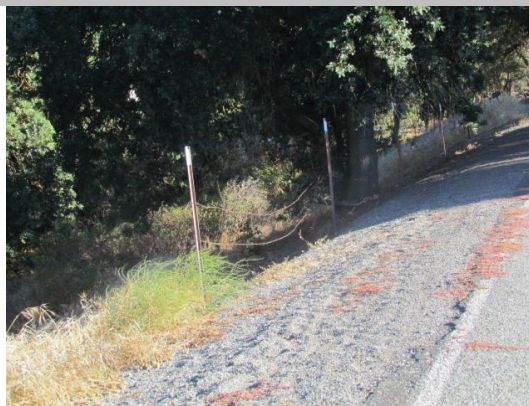
Photo 1 of 1 : SP\_2017\_RD0999\_236\_136\_20170314\_00092.jpg

LM Start	0.99	Rating **	M	Issue No.	136
LM End	1.02	Issue Type +	En	Location *	LS
Category	Earthen Levee			GPS Latitude/Longitude	
				Start	End
Item	Encroachments			38.346402 °	38.346800 °
				-121.580102 °	-121.579878 °
DWR ID	DWR_RD0999_05_f_2013_136				
Comment Code					
FE : Fence					
Inspector Comment					
Fencing on landward slope.

Looking northwest at fence on landward slope.

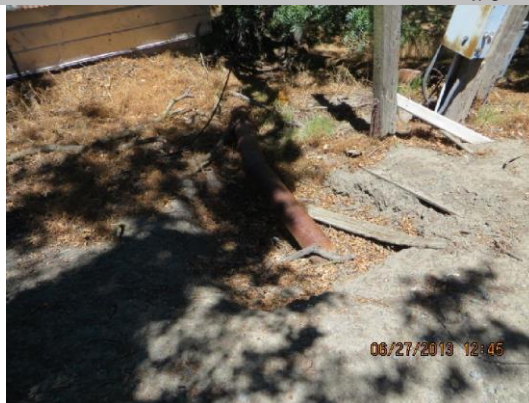
Photo 1 of 2 : UCIP\_SP\_2017\_16336\_27532.jpg

LM Start	1.13	Rating **	M	Issue No.	233
LM End	1.13	Issue Type +	En	Location *	LS
Category	Supplemental			GPS Latitude/Longitude	
				Start	End
Item	DWR UCIP Field Study			38.348113 °	38.348113 °
				-121.578841 °	-121.578841 °
DWR ID					
Comment Code					
Inspector Comment					
FS_ID:16336 DS_ID:23964 EP_NO: N/A Repair Type: Non-Urgent Crossing Status: Found UCIP Comments: Pipe appears abandoned and should be removed. FIELD_STRUCT_DESC: *Abandoned*10-inch steel irrigation pipe through levee 6.5-feet below crown. Pipe extends under metal walkway on WS shoulder. FS Date: 6/27/2013

Pipe visible on LS shoulder.

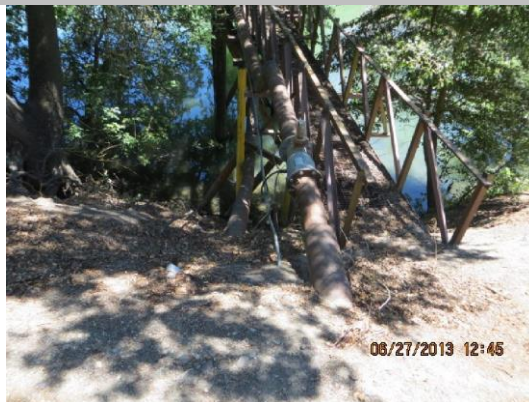
Photo 2 of 2 : UCIP\_SP\_2017\_16336\_27531.jpg

Pipe visible beneath 10-inch pipe that is currently in use. No connection.

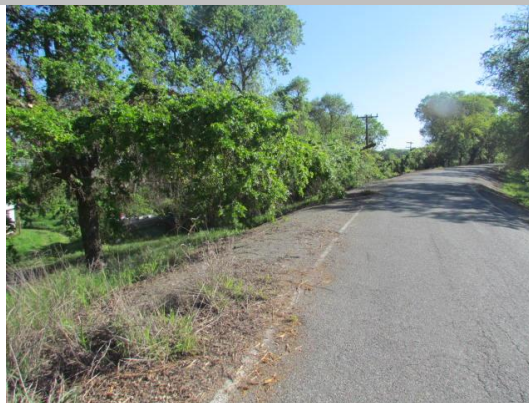
Photo 1 of 1 : SP\_2017\_RD0999\_236\_15\_20170314\_00016.jpg

LM Start	1.15	Rating **	U	Issue No.	15
LM End	1.19	Issue Type +	Ma	Location *	LS
Category	Earthen Levee			GPS Latitude/Longitude	
				Start	End
Item	Trim / Thin Trees			38.348237 °	38.348328 °
				-121.578440 °	-121.577735 °
DWR ID	DWR_RD0999_05_s_2012_15				
Comment Code					
T1 : Trim trees to at least five feet above ground level.					
Inspector Comment

Looking north at untrimmed trees on landward slope and toe.

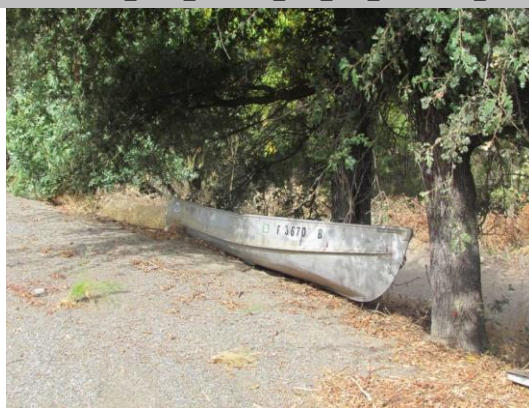
Photo 1 of 1 : SP\_2017\_RD0999\_236\_169\_20170314\_00016.jpg

LM Start	1.18	Rating **	M	Issue No.	169
LM End	1.18	Issue Type +	En	Location *	LS
Category	Earthen Levee			GPS Latitude/Longitude	
				Start	End
Item	Encroachments			38.348339 °	38.348339 °
				-121.577840 °	-121.577840 °
DWR ID	DWR_RD0999_05_f_2016_169				
Comment Code					
GA : Garbage					
Inspector Comment					
Boat stored on landward side.

Looking southwest at boat on landward slope.

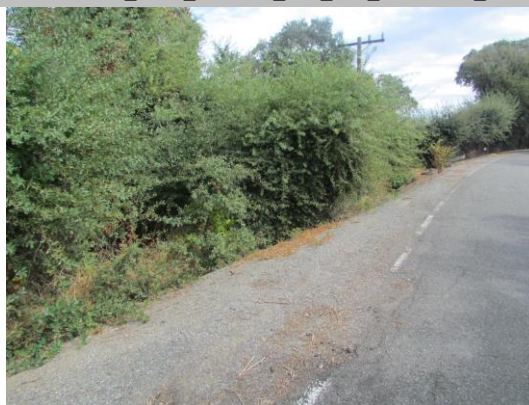
Photo 1 of 1 : SP\_2017\_RD0999\_236\_147\_20170314\_00097.jpg

LM Start	1.19	Rating **	U	Issue No.	147
LM End	1.19	Issue Type +	Ma	Location *	LS
Category	Earthen Levee			GPS Latitude/Longitude	
				Start	End
Item	Vegetation			38.348329 °	38.348329 °
				-121.577740 °	-121.577740 °
DWR ID	DWR_RD0999_05_f_2013_147				
Comment Code					
V2 : Remove the wild growth other than native grasses from the levee slopes.					
Inspector Comment					
Dense vegetation at landward toe.

Looking northwest at untrimmed trees on landward slope.

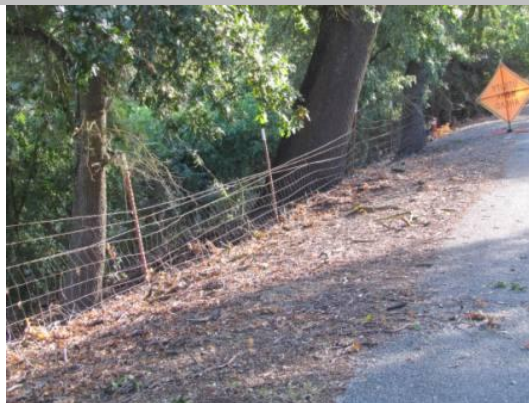
Photo 1 of 1 : SP\_2017\_RD0999\_236\_76\_20170314\_00061.jpg

LM Start	1.20	Rating **	M	Issue No.	76
LM End	1.22	Issue Type +	En	Location *	LS
Category	Earthen Levee			GPS Latitude/Longitude	
				Start	End
Item	Encroachments			38.348336 °	38.348332 °
				-121.577621 °	-121.577172 °
DWR ID	DWR_RD0999_05_s_2012_76				
Comment Code					
FE : Fence					
Inspector Comment					
Fence is located on landside shoulder.

Looking north at fence along landside slope.

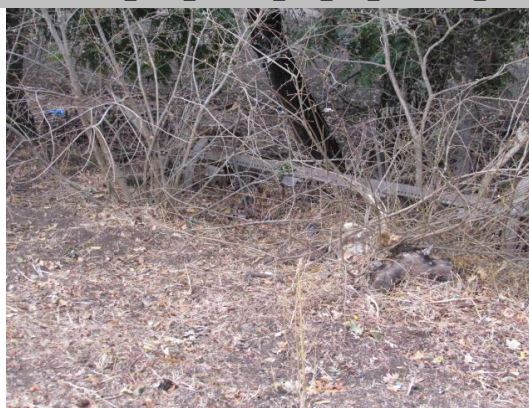
Photo 1 of 1 : SP\_2017\_RD0999\_236\_171\_20170314\_00112.jpg

LM Start	1.25	Rating **	M	Issue No.	171
LM End	1.25	Issue Type +	En	Location *	LS
Category	Earthen Levee			GPS Latitude/Longitude	
				Start	End
Item	Encroachments			38.348319 °	38.348319 °
				-121.576566 °	-121.576566 °
DWR ID	DWR_RD0999_05_f_2015_171				
Comment Code					
EQ : Equipment					
Inspector Comment					
Old farm equipment on landward slope

Looking at farm equipment on landward slope.

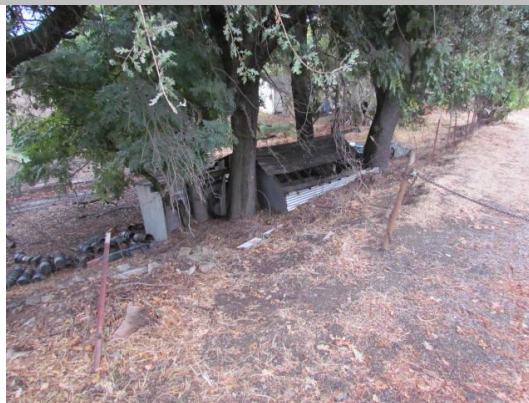
Photo 1 of 3 : SP\_2017\_RD0999\_236\_172\_20170314\_00113.jpg

LM Start	1.27	Rating **	U	Issue No.	172
LM End	1.27	Issue Type +	En	Location *	LS
Category	Earthen Levee			GPS Latitude/Longitude	
				Start	End
Item	Encroachments			38.348304 °	38.348304 °
				-121.576207 °	-121.576207 °
DWR ID	DWR_RD0999_05_f_2015_172				
Comment Code					
BU : Building					
Inspector Comment					
Toolshed excavated into landward toe.

Looking southwest at toolshed at landward toe.

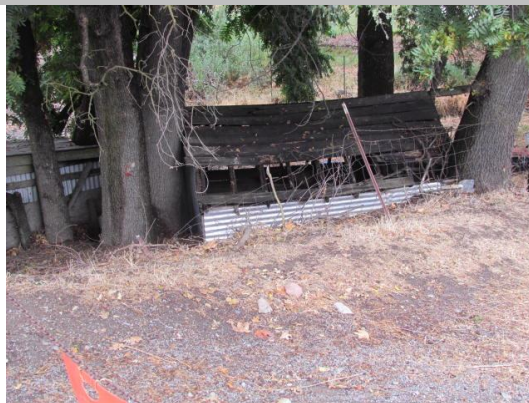
Photo 2 of 3 : SP\_2017\_RD0999\_236\_172\_20170314\_00114.jpg

LM Start	1.27	Rating **	U	Issue No.	172 (cont)	
LM End	1.27	Issue Type +	En	Location *	LS	
Category	Earthen Levee			GPS Latitude/Longitude		
				Start		End
Item	Encroachments			38.348304 °		38.348304 °
				-121.576207 °		-121.576207 °
DWR ID	DWR_RD0999_05_f_2015_172					
Comment Code						
BU : Building						
Inspector Comment						
Toolshed excavated into landward toe.

Looking west at toolshed at landward toe.

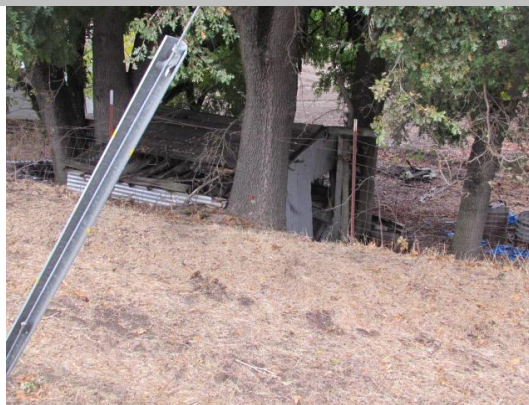
Photo 3 of 3 : SP\_2017\_RD0999\_236\_172\_20170314\_00115.jpg

Looking at northwest at toolshed at landward toe.

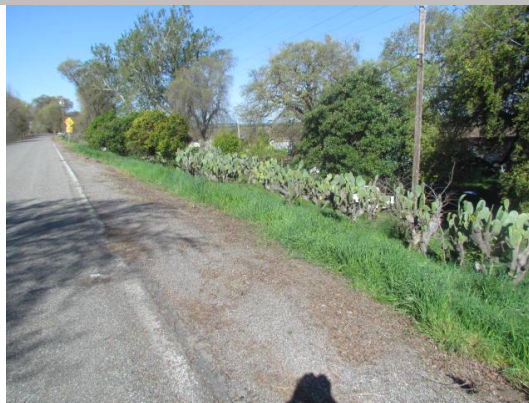
Photo 1 of 4 : SP\_2017\_RD0999\_236\_2\_20170314\_00001.jpg

LM Start	1.28	Rating **	U	Issue No.	2
LM End	1.36	Issue Type +	En	Location *	LS
Category	Earthen Levee			GPS Latitude/Longitude	
				Start	End
Item	Vegetation			38.348278 °	38.348188 °
				-121.576078 °	-121.574690 °
DWR ID	DWR_RD0999_05_s_2012_2				
Comment Code					
V6 : Landscaping					
Inspector Comment					
Control landscaping on landward slope. Landowner has trimmed landscaping. But has not removed century plant on landward shoulder.

Looking southwest at dense cactus plants on landward slope and toe.

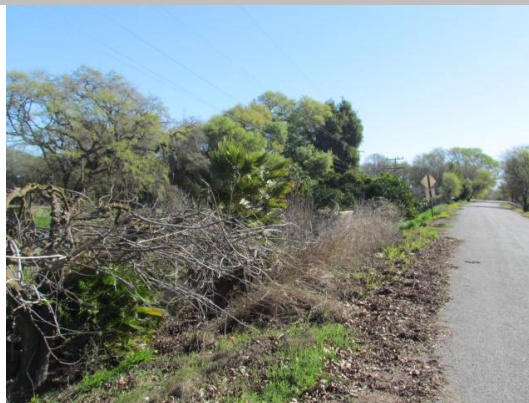
Photo 2 of 4 : SP\_2017\_RD0999\_236\_2\_20170314\_00002.jpg

Looking south at landscaping on landward slope.

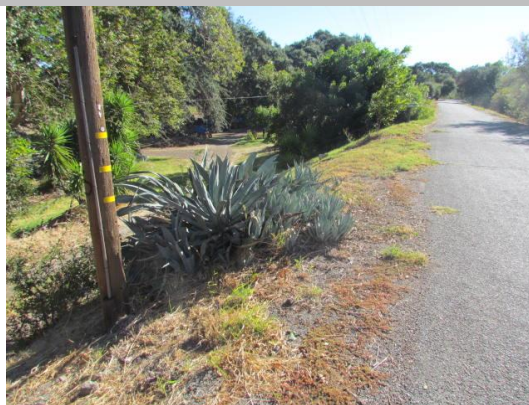
Photo 3 of 4 : SP\_2017\_RD0999\_236\_2\_20170314\_00003.jpg

Looking northwest at landscaping on landward slope.

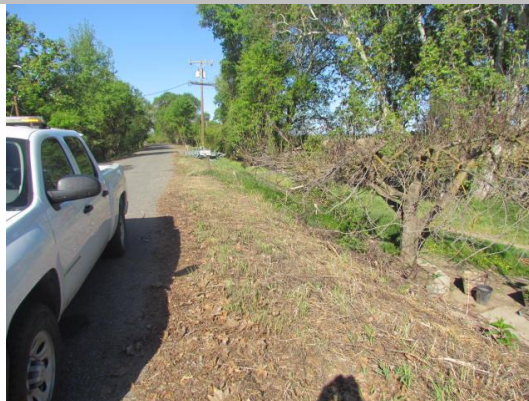
Photo 4 of 4 : SP\_2017\_RD0999\_236\_2\_20170314\_00004.jpg

Looking south at landward slope. (Spring 2015)

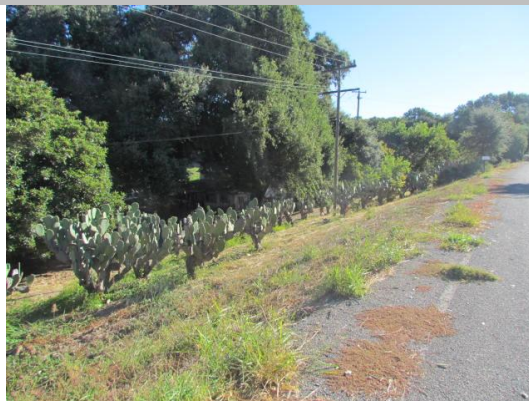
Photo 1 of 1 : SP\_2017\_RD0999\_236\_149\_20170314\_00098.jpg

LM Start	1.38	Rating **	M	Issue No.	149
LM End	1.41	Issue Type +	En	Location *	LS
Category	Earthen Levee			GPS Latitude/Longitude	
				Start	End
Item	Vegetation			38.348149 °	38.348111 °
				-121.574248 °	-121.573699 °
DWR ID	DWR_RD0999_05_f_2013_149				
Comment Code					
V6 : Landscaping					
Inspector Comment					
Large cactus plants on landward slope.

Looking northwest at several cactus plants on landward slope.

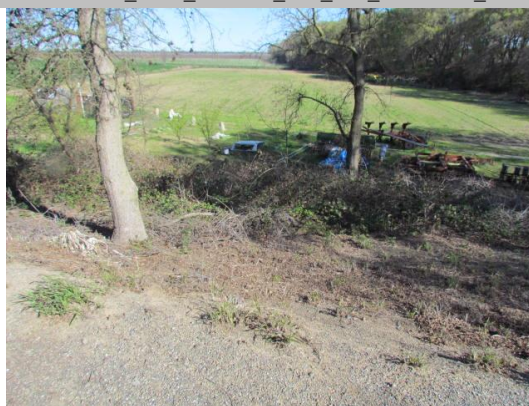
Photo 1 of 2 : SP\_2017\_RD0999\_236\_129\_20170314\_00087.jpg

LM Start	1.39	Rating **	M	Issue No.	129
LM End	1.39	Issue Type +	Ma	Location *	LS
Category	Earthen Levee			GPS Latitude/Longitude	
				Start	End
Item	Vegetation			38.348100 °	38.348100 °
				-121.574075 °	-121.574075 °
DWR ID	DWR_RD0999_05_s_2012_129				
Comment Code					
V2 : Remove the wild growth other than native grasses from the levee slopes.					
Inspector Comment					
Berry vines and century plants on landside toe and slope.

Looking southwest at berry vines on landward slope.

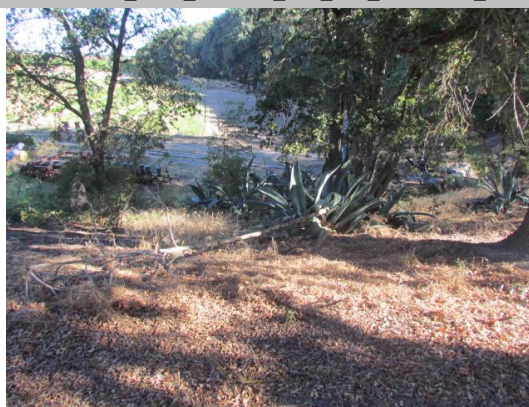
Photo 2 of 2 : SP\_2017\_RD0999\_236\_129\_20170314\_00088.jpg

Looking west at century plants on landward slope.

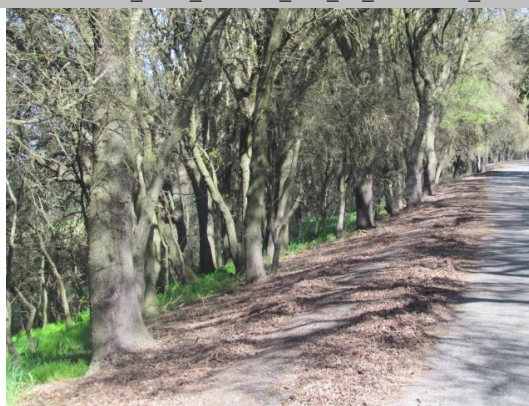
Photo 1 of 1 : SP\_2017\_RD0999\_236\_18\_20170314\_00020.jpg

LM Start	1.46	Rating **	U	Issue No.	18
LM End	1.83	Issue Type +	Ma	Location *	LS
Category	Earthen Levee			GPS Latitude/Longitude	
				Start	End
Item	Trim / Thin Trees			38.348670 °	38.353852 °
				-121.573320 °	-121.573570 °
DWR ID	DWR_RD0999_05_s_2012_18				
Comment Code					
T3 : Trim and thin trees to allow visibility of the ground and room to flood fight.					
Inspector Comment

Looking east at dense trees on landward slope.

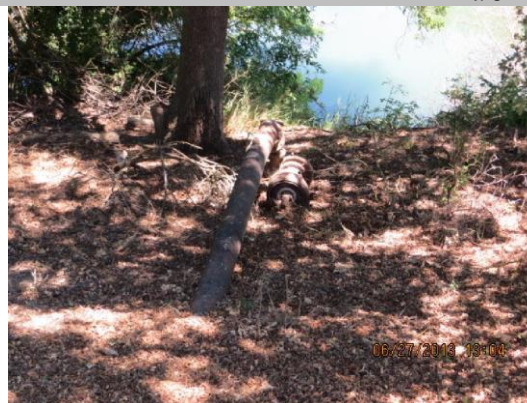
Photo 1 of 2 : UCIP\_SP\_2017\_15421\_25323.jpg

LM Start	1.83	Rating **	M	Issue No.	234
LM End	1.83	Issue Type +	En	Location *	WS
Category	Supplemental			GPS Latitude/Longitude	
				Start	End
Item	DWR UCIP Field Study			38.353864 °	38.353864 °
				-121.573577 °	-121.573577 °
DWR ID					
Comment Code					
Inspector Comment					
FS_ID:15421 DS_ID:22847 EP_NO: N/A Repair Type: Non-Urgent Crossing Status: Found UCIP Comments: Abandoned and should be done so properly. FIELD_STRUCT_DESC: *Abandoned* 8-inch pipe through levee 4.7 feet below crown. Pump house on the waterward slope. Both ends open. Originally included in the 1966 O&M manual. FS Date: 6/27/2013

Pipe and pump remnants on WS slope.

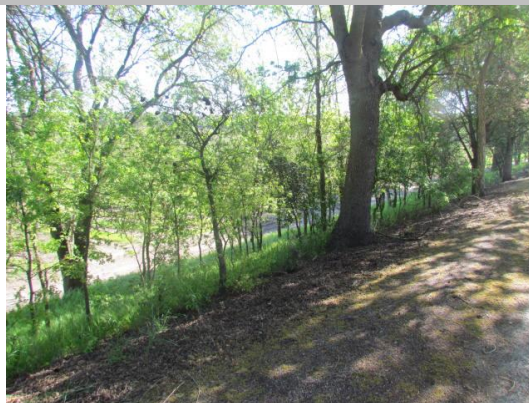
Photo 1 of 1 : SP\_2017\_RD0999\_236\_24\_20170314\_00023.jpg

LM Start	2.14	Rating **	M	Issue No.	24
LM End	2.16	Issue Type +	Ma	Location *	LS
Category	Earthen Levee			GPS Latitude/Longitude	
				Start	End
Item	Trim / Thin Trees			38.355402 °	38.355282 °
				-121.568893 °	-121.568547 °
DWR ID	DWR_RD0999_05_s_2012_24				
Comment Code					
T3 : Trim and thin trees to allow visibility of the ground and room to flood fight.					
Inspector Comment

Looking west at dense trees on landward slope. (Spring 2015)

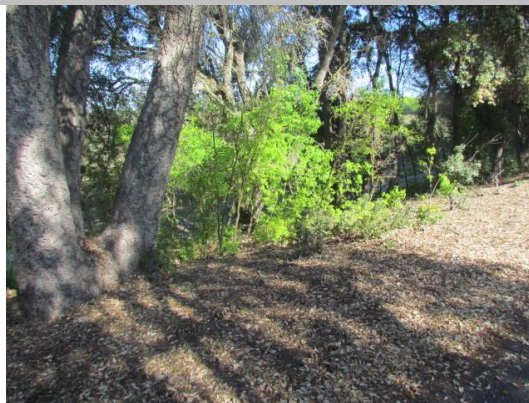
Photo 1 of 1 : SP\_2017\_RD0999\_236\_82\_20170314\_00066.jpg

LM Start	2.51	Rating **	M	Issue No.	82
LM End	2.65	Issue Type +	Ma	Location *	LS
Category	Earthen Levee			GPS Latitude/Longitude	
				Start	End
Item	Trim / Thin Trees			38.356270 °	38.358132 °
				-121.563218 °	-121.562347 °
DWR ID	DWR_RD0999_05_s_2012_82				
Comment Code					
T3 : Trim and thin trees to allow visibility of the ground and room to flood fight.					
Inspector Comment

Looking northwest at dense trees on landward slope. (Spring 2015)

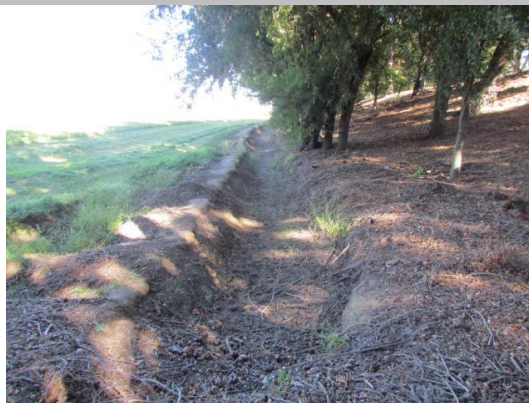
Photo 1 of 1 : SP\_2017\_RD0999\_236\_152\_20170314\_00099.jpg

LM Start	2.86	Rating **	M	Issue No.	152
LM End	3.12	Issue Type +	En	Location *	LS
Category	Earthen Levee			GPS Latitude/Longitude	
				Start	End
Item	Encroachments			38.361047 °	38.364409 °
				-121.563113 °	-121.561941 °
DWR ID	DWR_RD0999_05_f_2013_152				
Comment Code					
DT : Ditch					
Inspector Comment					
Irrigation ditch has been in place for several years at landward toe.

Looking north at abandoned irrigation ditch at landward toe.

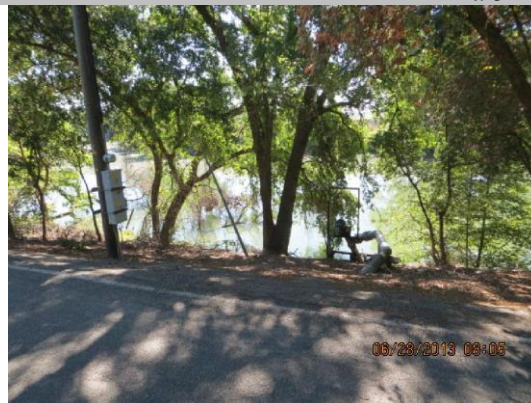
Photo 1 of 3 : UCIP\_SP\_2017\_50093\_25332.jpg

FS\_ID:50093  
DS\_ID:22849  
EP\_NO: 7378  
Repair Type: Urgent  
Crossing Status: Found  
UCIP Comments: 07/07/2016 - LS toe of levee still has erosion around stand pipe and adjacent oak tree. Erosion does not appear to be any worse than during previous inspection. no water in canal on LS toe led to the discovery of two additional appurtenant structures. (T. Hatch/UCIP)06/28/2013 - Pipe outlet is eroding the LS slope of the levee, exposing the roots of an oak and threatening greater damage if allowed to continue. (W. Wylie/UCIP)  
FIELD\_STRUCT\_DESC: 10-inch steel irrigation pipe through the levee, 6 feet below the crown. Slant pump and service pole on the waterside (WS) slope. 36-inch concrete standpipe on the landside (LS) toe (Permit No. 7378, 1971 - Volz). Replaced an existing 8-inch pipe at the same location. [Additional Reference(s): DWR Levee Logs, 1992].  
FS Date: 7/7/2016

LM Start	<b>3.02</b>	Rating **	U	Issue No.	<b>235 (cont)</b>
LM End	<b>3.02</b>	Issue Type +	En	Location *	WS

Slant pump, JP, and meter on WS slope.
